Contamination profile of Printed Circuit Board Assemblies in relation to soldering types and conformal coating

Published in:
Proceedings of EuroCorr 2014

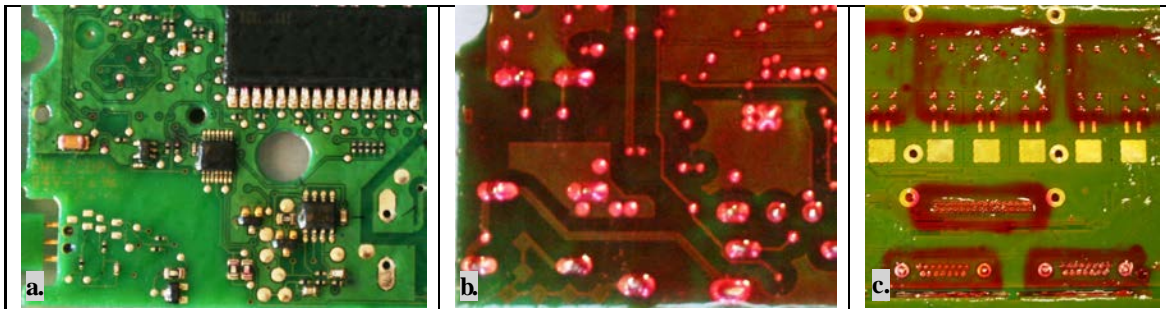
As shown in Fig. 1a, reflow soldered PCBAs in general did not show any red coloration indicative of the absence of residues. On the other hand, PCBAs that have undergone wave and selective soldering process have shown intense colour change including clear indication of the mark of pallet used in the case of selective soldering (Fig. 1b and 1c). The red coloration in both cases indicates the presence of high levels of flux residue.

Figure 1: Residues RAT gel test on a) reflow, b) wave and c) selective wave soldered PCBs

While red coloration was seen all over the surface of the wave soldered PCBAs (Fig. 1b) (although only part of it is shown), selective soldered PCBAs showed residues only over a selected area depending on the application procedure (Fig. 1c).

Figure 1 shows partial images of typical PCBAs tested with Residue RAT, revealing the localized contaminations on the PCBA surface as a function of involved soldering process. The patented Residues RAT gel makes use of pH change due to the presence of acid in the flux residue to reveal the colour change in an optimized manner [7].

The observation can be explained by the type of flux application in different soldering process.

For reflow soldering process, the use of flux in the form of paste and screen printing process limit the location of residues only to the localized areas, for example very close to or under the components.

Although only few PCBAs are shown in Figure 1, the results shown here represent typical levels of residues found based on the test carried out on a large number of PCBAs with various designs and three soldering process. Therefore the results are applicable as a relative comparison between the cleanliness levels of various soldering process using no-clean flux systems.

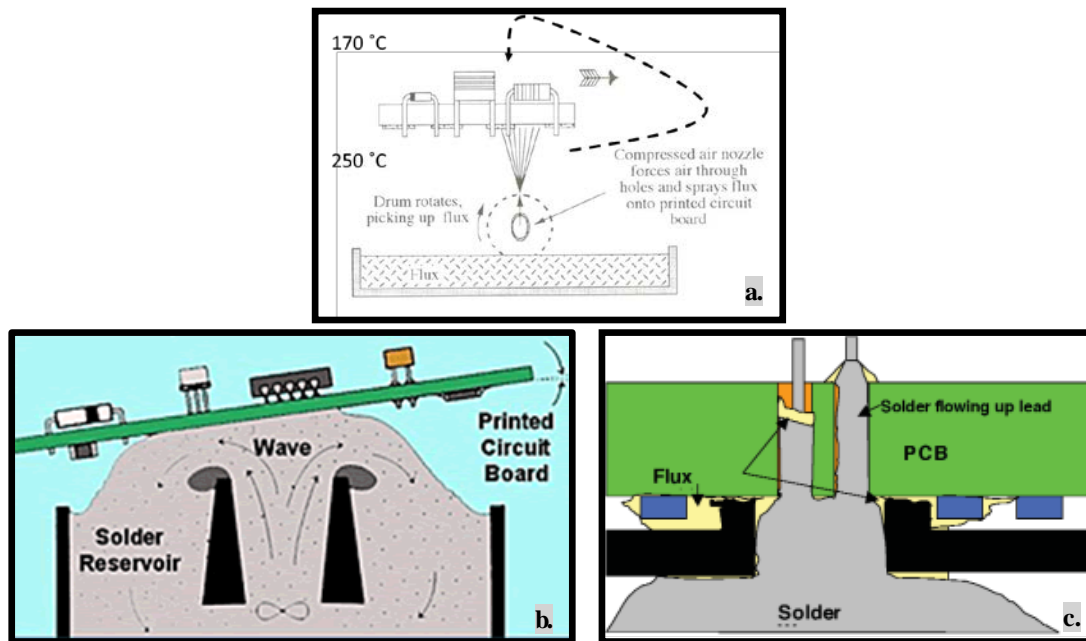
Figure 2 : Schematics of a) flux spraying at the bottom of the PCB to remove oxide on the through hole component leads and solder pad [10], b) through hole assembled PCB passing through the molten solder wave [11] and c) selective wave soldering process using a pallet [12]

In wave and selective soldering process, the flux is sprayed onto the bottom side of the PCBA, therefore resulting in wider distribution of flux on the surface. A large number of droplets can be left on the top of the PCBA, through via-holes, and the difference in the temperature of the top and bottom parts of the PCBA during soldering could introduce higher amounts of residue on the top part, where the temperature reaches only up to 170 °C (Figure 3 a and b).

In the case of selective wave soldering process, flux can be sweep under the pallet, and these trapped residues are not exposed to a sufficient temperature to be degraded (Figure 3 c).

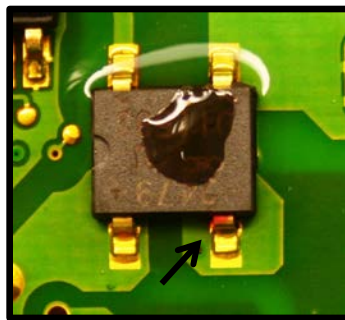
Reflow soldering flux residue can be concealed initially due to the presence of the binder and the resin part of the flux, and WOA may not be immediately released [10]. Fig. 3 shows the residue RAT gel test of the reflowed PCB after five cycles of water spraying following by slow drying under an UV light in order to open up the residues. It can be seen that after this treatment a small red spot appears under the component, showing the release of WOA. The residues were found to be concealed initially and require heavy exposure to humidity for opening up [13].

Figure 3: Residues RAT gel test on reflow soldered PCBA after severe humidity exposure

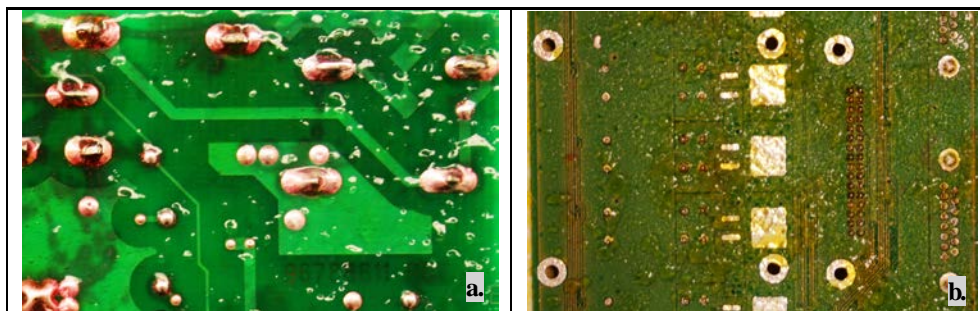
Fig. 3 shows images of Residue RAT gel test, of a typical wave and selective soldered PCBAs similar to the ones shown above in Figures 1b and 1c, however, after a simple cleaning process, by rinsing with a solution of Isopropyl alcohol and Millipore water at 3:1 ratio and scrubbing with a soft tissue, and rinsed again with the same solution to avoid any additional contaminations from the tissue. It is clearly showed that the acid residues are decreased, however little residues were found at some localized regions.

Figure 4: Residues RAT gel test on cleaned a) wave soldered PCBAs and b) selective wave soldered PCBAs

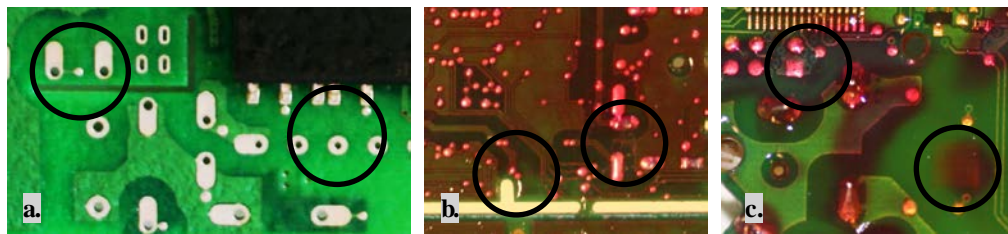
Figure 6: Selected areas for optical microscope pictures, of a) reflow b) wave and c) selective wave soldered and coated PCBs

Performance of the conformal coating on the contaminated PCBAs were evaluated by exposure to 40°C and 98% RH for 3 weeks, and by observing the change in morphology of the coating due to blister formation. Only typical results before and after exposure to humidity are shown in Fig. 7-9, and for comparison of the initial level of contamination, Figure 6 consists of Residue RAT tested surface of same PCBAs with circles showing examined area for blisters. Fig. 8 and 9 also show the results for cleaned PCBAs which are conformal coated and tested.

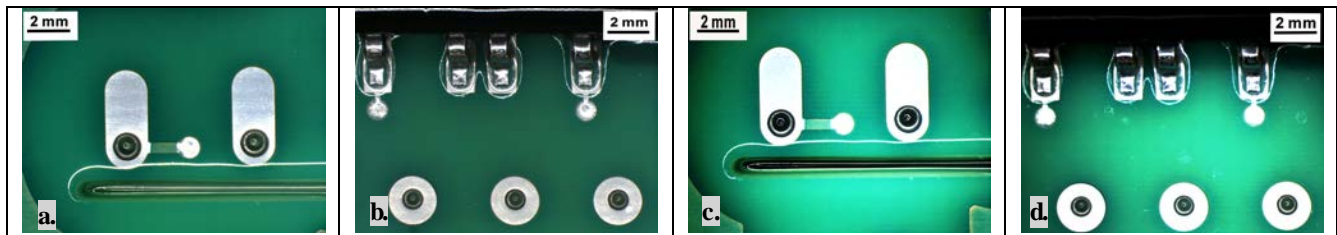
Figure 7: Optical microscope pictures of reflow soldered and coated PCB, a) b) before and c) d) after 3 weeks exposure to saturated humid

Results show that the conformal coating on reflow soldered PCBA remained unaffected during the three weeks of exposure (Fig. 7) (no blisters were found on the surface). But on wave and selective soldered PCBAs (Fig. 8 and 9), the conformal coating showed signs of deterioration and the majority of the blisters appeared at the same areas where a high level of contaminations were found by the Residue Rat testing. It clearly indicated that the excessive levels of contamination could introduce problems for conformal coating under humid conditions. This is expected, as the ionic contaminants under the coating will influence the water transport through the coating due to osmotic pressure, while the adhesion of the coating is affected by the contamination at the interface [14-16].

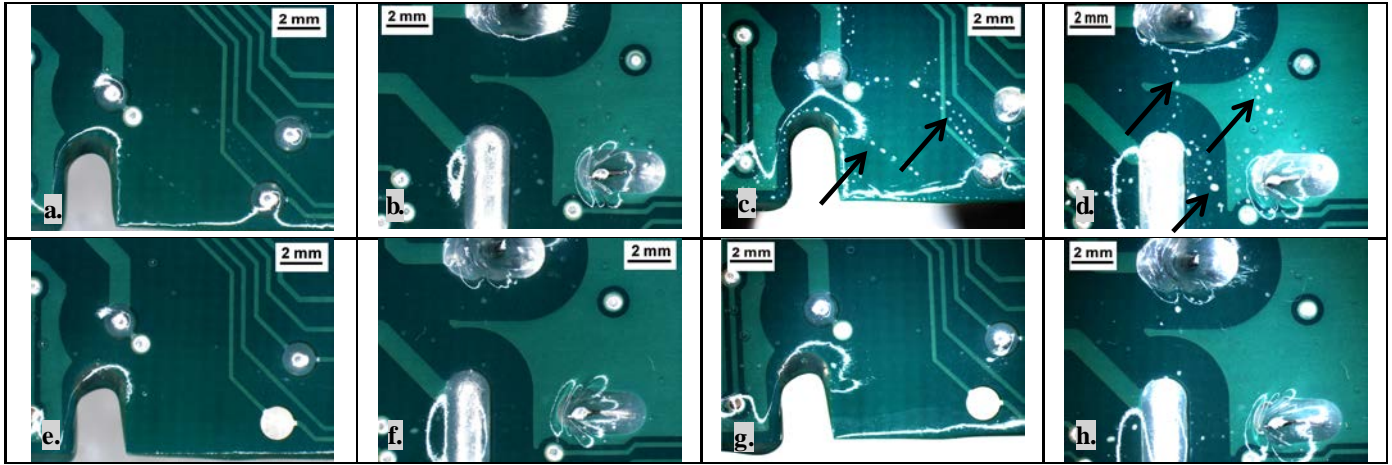
Figure 8: Optical microscope pictures of as received wave soldered and coated PCB, a) b) before and c) d) after 3 weeks exposure to saturated humid, and cleaned wave soldered and coated PCB, e) f) before and g) h) after 3 weeks exposure to saturated humid

However, in both cases, cleaning of the PCBA has enhanced the performance of the conformal coating, indicating a direct relation between the contamination and the blister formation.

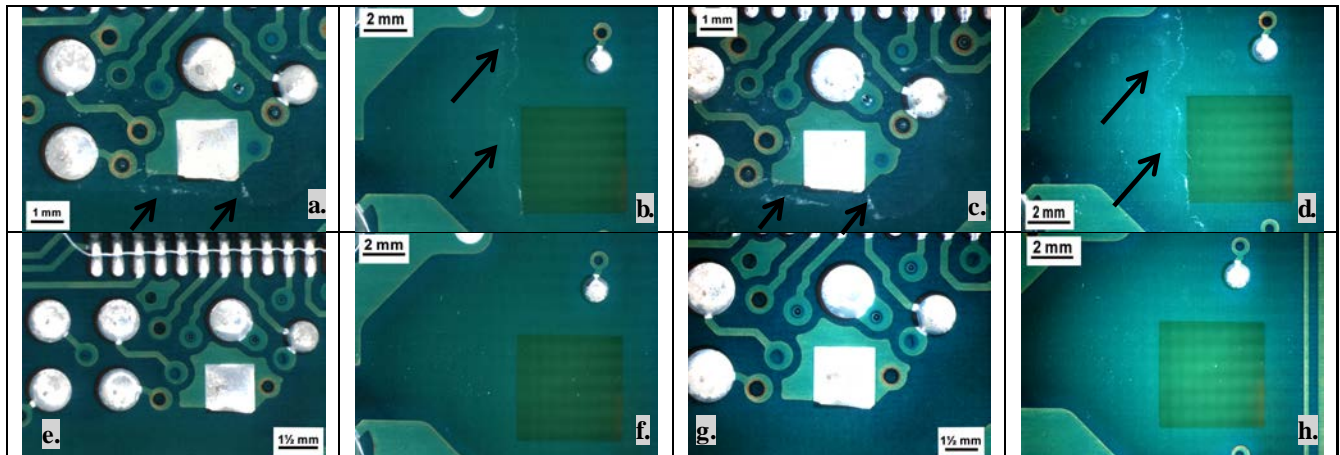
Figure 9: Optical microscope pictures of as received selective wave soldered and coated PCB a) b) before and c) d) after 3 weeks exposure to saturated humid, and cleaned selective wave soldered and coated PCB, e) f) before and g) h) after 3 weeks exposure to saturated humid
